Manhole Inspection Summary

Manhole # S17G__039MH

Insp Date: **10/5/07 1:26 PM**

Location Address: **1 GORMAN-BENTALOU**

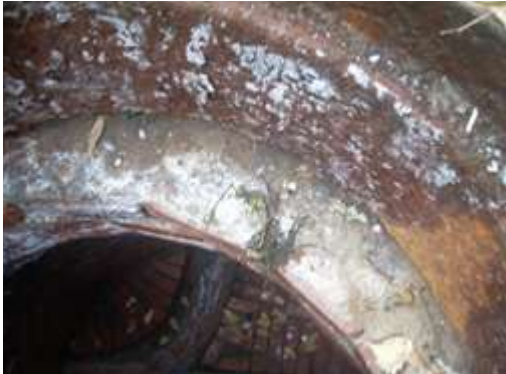
Defect 1

Frame Offset: **3** (in.) Condition: ☒ Sound ☐ Cracked ☐ Leaks

FRAME OFFSET

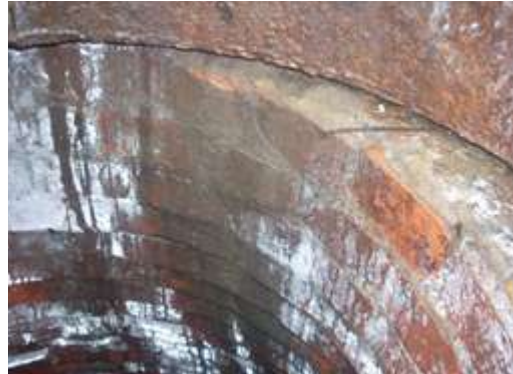
Defect 2

Infiltration: ☐ None ☒ **Joint** ☐ Cracks ☐ Mortar ☐ Roots ☐ Wall

JOINT INFILTRATION

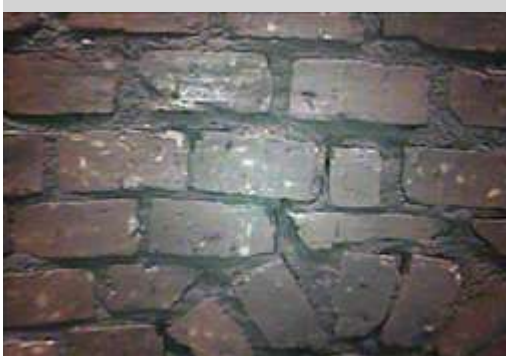
Defect 4

Condition: ☐ Sound ☒ **Cracked** ☐ Root Intrusion ☐ Loose Brick ☐ Deteriorated

CRACKED BARREL

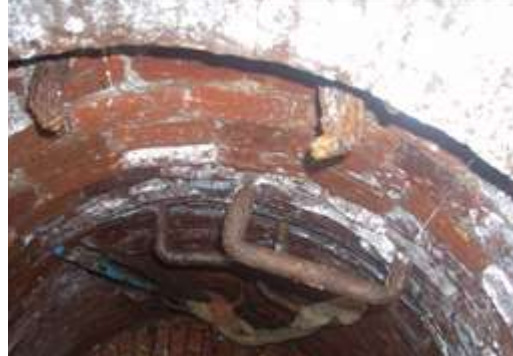
Defect 3

Steps Count: **4** Missing: **1** ☒ **Corroded**

CORRODED AND MISSING STEP
